# Status of Public Water Supply Facilities in Port Harcourt Metropolis

Geraldine Okwy Ojukwu, Hycienth Ogunka Nwankwoala. Status of Public Water Supply Facilities in Port Harcourt Metropolis.

*International Journal of Environmental Protection and Policy*. Vol. 10, No. 2, 2022, pp. 31-38. doi: 10.11648/j.ijepp.20221002.13

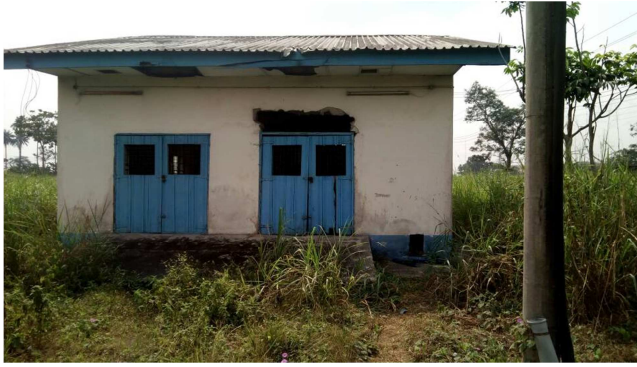
Table 2 shows operational capacities of the PHWC water stations and their status as at the time of assessment. The facilities are generally underutilized and in poor working conditions. The status of the Rumuola Water Station facilities is presented in Table 3. It was observed the facilities were poorly maintained, working below capacity, armored cable vandalized by hoodlums at the transformer powering one of the 3 wells that are functional, collapsed fence at the back of the facility granting hoodlums access into the facility; and bushy fields covered most of the facility (Figure 1).

**Figure 1.** Dilapidated generator house showing vandalized armored cable at Rumuola water station.

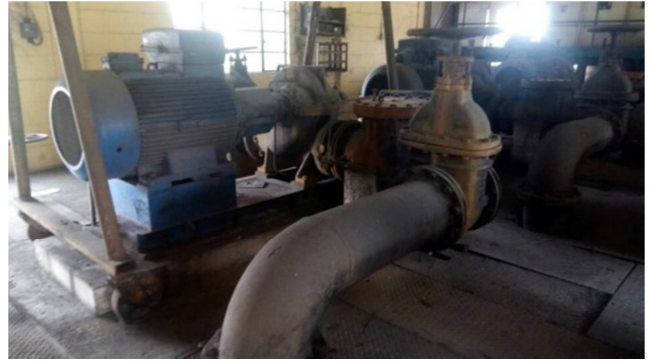
Table 4 shows the status of facilities at Diobu water station. As observed, booster pumps no. 3 and 6 are functioning, but their faults are mainly mechanical; booster panel no: 3 and 6 are functioning; with a capacity of 864 cubic meters each; generator sets (2No), 725KVA and 875KVA, 725KVA functioning with minor issues (battery); poor drainage system, experiences floods during rainfall inside the powerhouse; overhead tanks (2) cylindrical and funnel, the cylindrical tank has a faulty valve; and the surroundings were bushy (Figures 4 and 5).

**Figure 4.** Fairly maintained engine room and an overhead tank at Diobu Water Station.

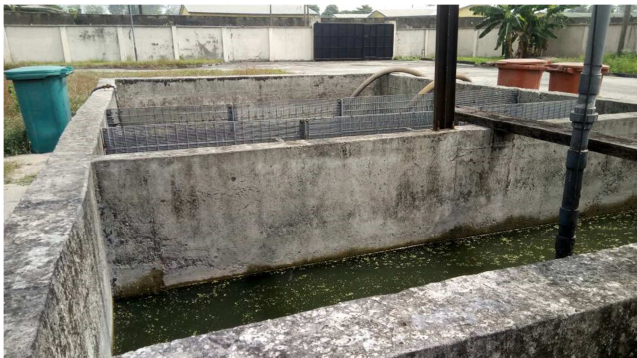
At Eagle Island water pumping station, not much activity was going on in this facility as equipment have been vandalized (Figure 2).

**Figure 2.** Non-functional treatment tank at Eagle Island Treatment Plant.

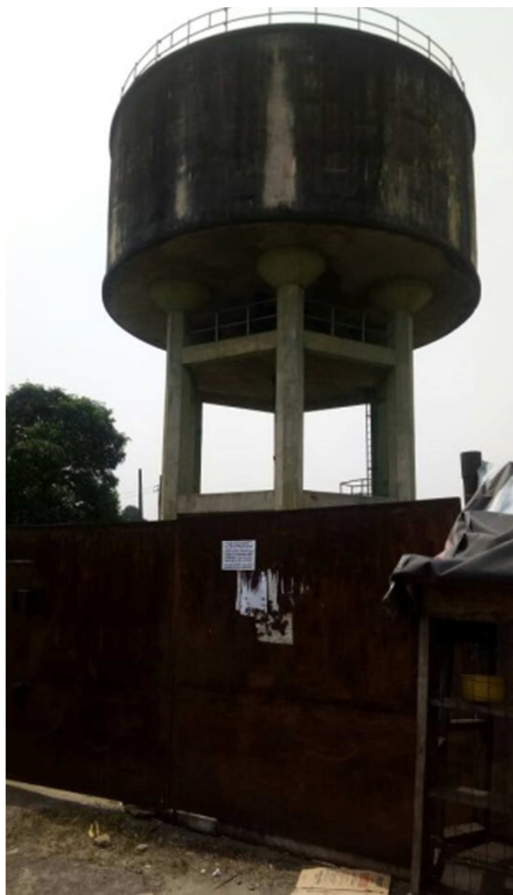
For Borokiri Water Station, at the time of visit the station was locked and access could not be gained to this facility. However, observations made showed that no activity has been going on in the facility for some time and the structures therein are under neglect (Figure 3).

**Figure 3.** An overhead tank at Borokiri Station.

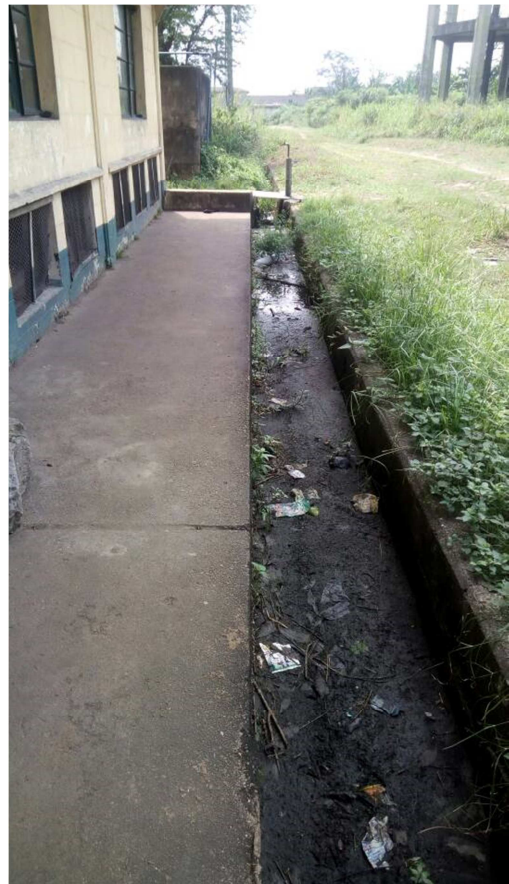
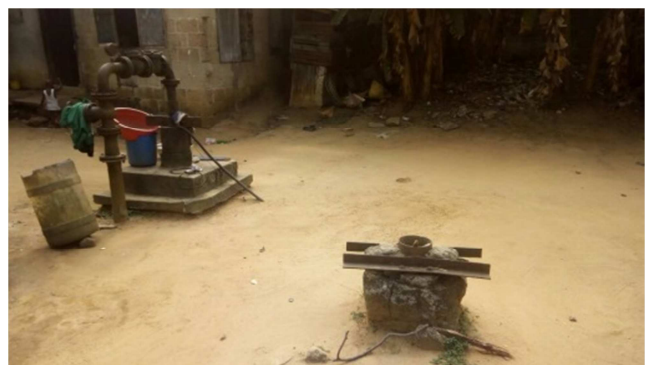
**Figure 5.** Poorly maintained drainage and surroundings at Diobu Water Station.

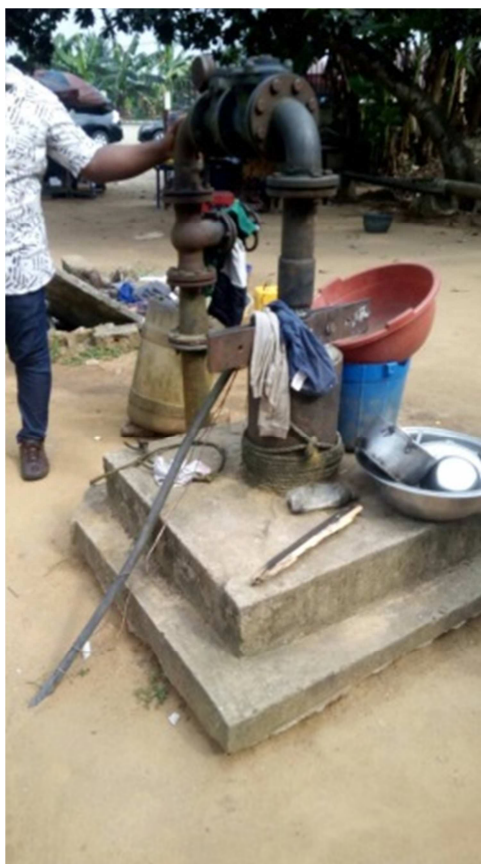
At Ernest Ikoli Water Station, generally, this facility looks abandoned as no activity was observed going there (Figure 6).

**Figure 6.** Abandoned structures at the Ernest Ikoli water station.

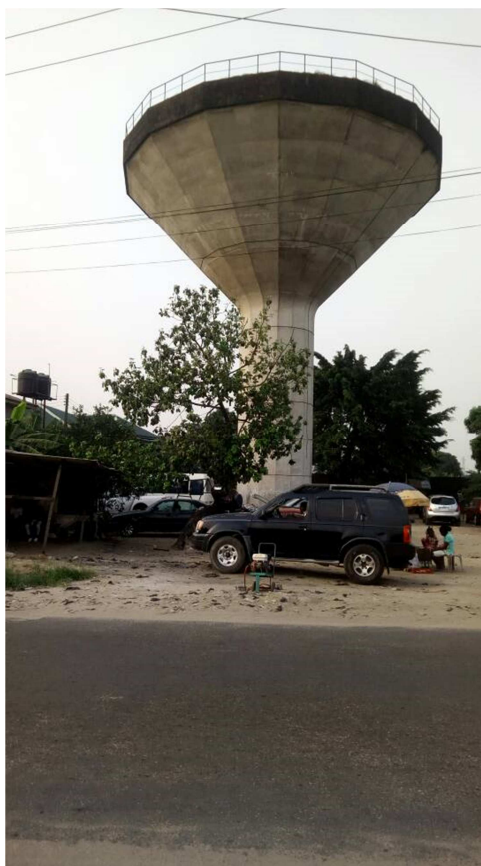
At Omerelu Street, GRA Phase 2 water station, the compound is presently used as a mechanic yard and waste litter the environment (Figures 7 and 8).

**Figure 7.** Overhead tank at Omerelu Street, GRA Phase 2.

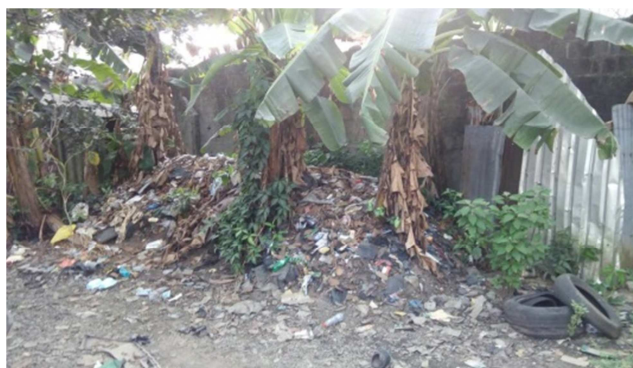
**Figure 8.** Waste dump surrounding Omerelu Street overhead tank, GRA Phase 2.

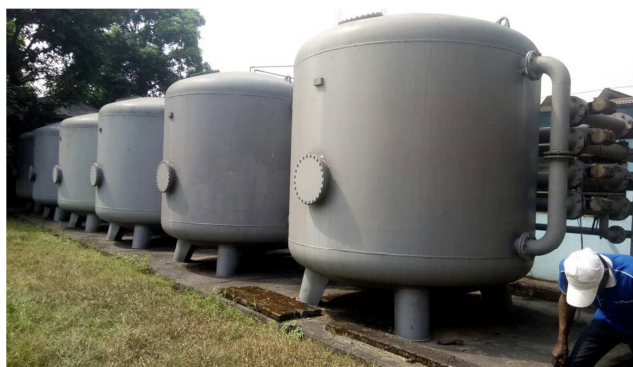
**Figure 9.** Properly maintained water tanks and pumping station at Moscow Road.

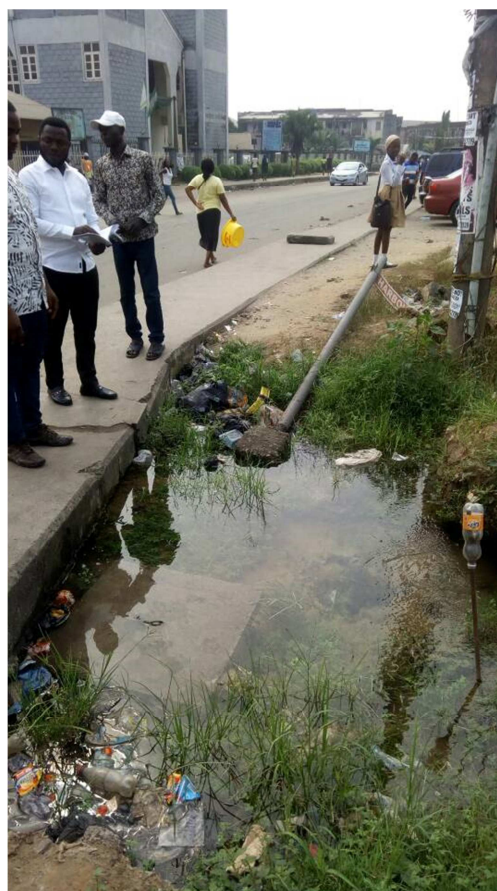
Reclamation (Macoba) Road, NPA axis etc. The water tank is normally washed once in a year. Figure 9 shows properly maintained water tanks and pumping station at Moscow Road water station. water leakages were observed along Aggrey road at the following locations and coordinates First Bank, Aggrey Road and 9, Aggrey Road, by Young Model Supermarket (Figure 10).

**Figure 10.** Lines from Moscow station showing leakages and refuse.

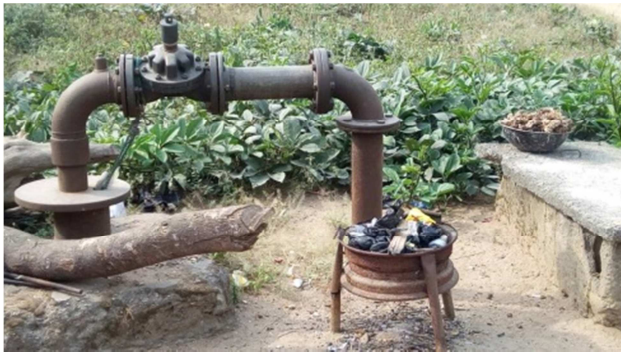
For Elelenwo Water Station, observations within this facility include: a borehole which is also not well maintained; abandoned generator set, two overhead tanks (one, in a bad state presently); and an open burning of waste close to fence

**Figure 11.** Dilapidated overhead tanks and abandoned borehole at Elenwo Water Station.

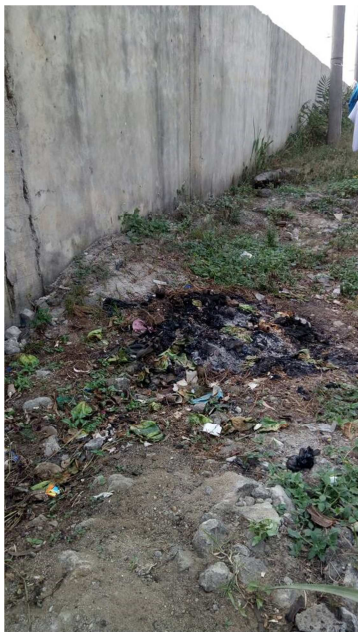
**Figure 12.** Waste litter the surroundings of Elenwo Water Station and burning of waste close to the fence.

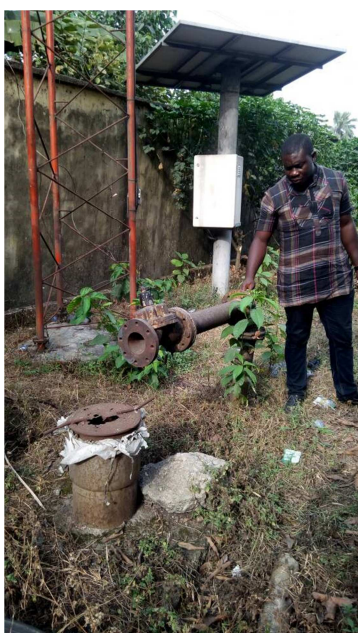
At Rumuokwurushi Water Station, observations showed that the station is not functioning as most of the equipment have broken down and require major repairs (Figure 13).

**Figure 13.** The facilities at Rumuokwurushi Water Station under disrepair.

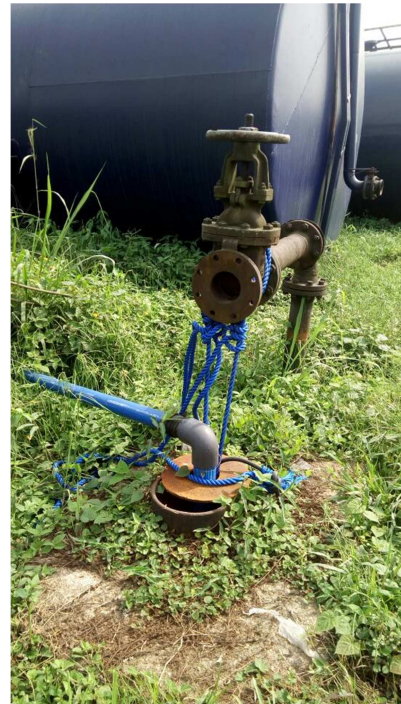
At Trans Amadi Water Station, the facilities observed include four Boreholes (1 abandoned but converted into use by a Gas Company operating within the premises); one cylindrical overhead tank; and one contact tank. Open waste dumps also litter the surroundings of this station and some waste dumps have been burnt closed to the fence (Figures 14 and 15).

**Figure 14.** Borehole converted and put into use by a Gas Company operating within the premises.

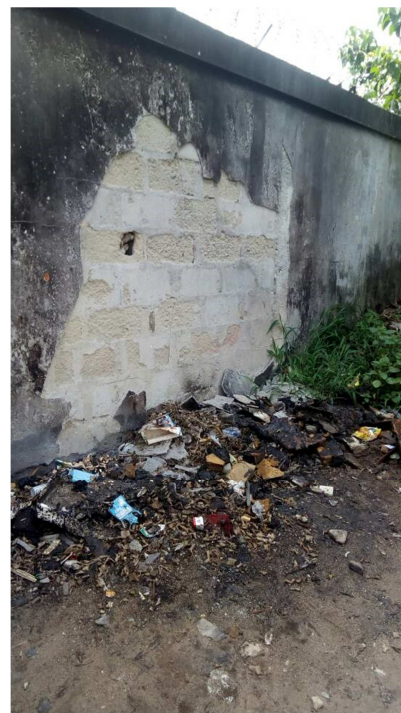
**Figure 15.** Open burning of waste close to fence wall at Trans Amadi water station.
